Manhole Inspection Summary

Manhole # S23KK_054MH

Location Address: **2448 WOODBROOK AVE**

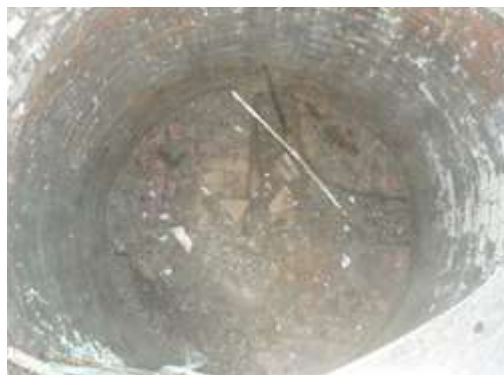
Top View

Bench and Channel debris.

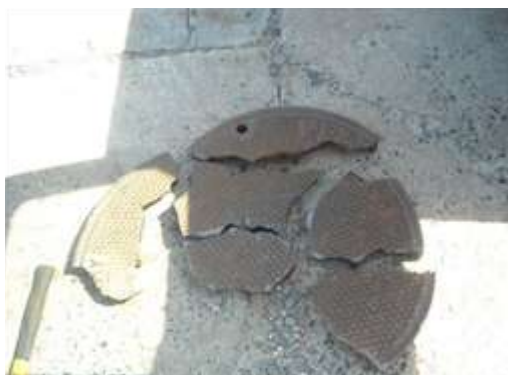
Broken lid

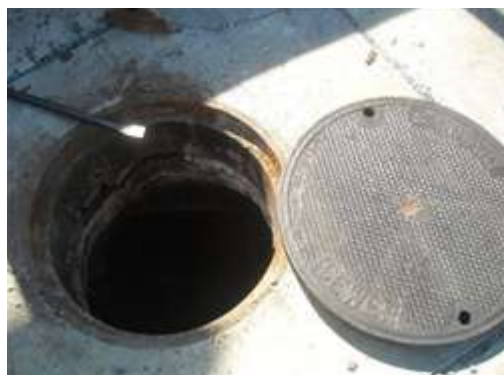
Replacement lid

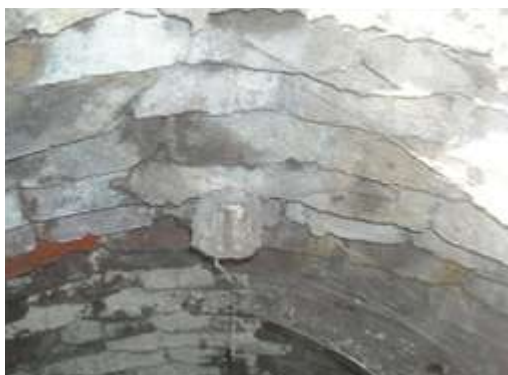
Old faucet

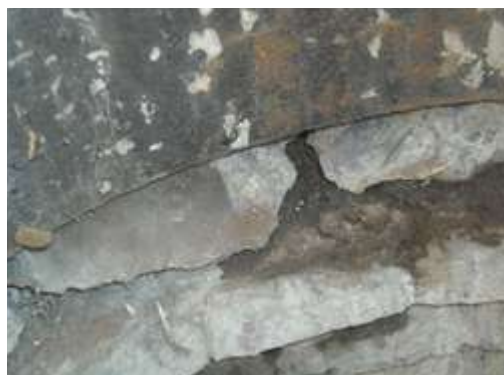
Defect

Frame leaks. Frame offset. Adjustment deterioration, loose brick and infiltration.

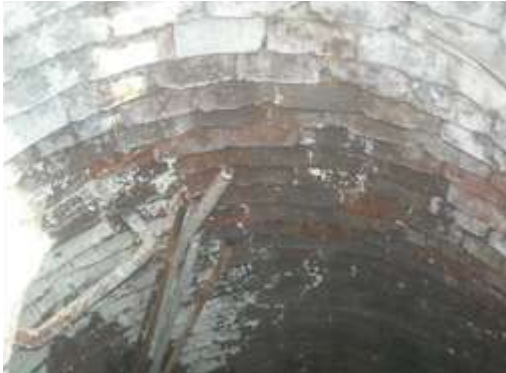
Defect

Adjustment, Corbel and Barrel infiltration.

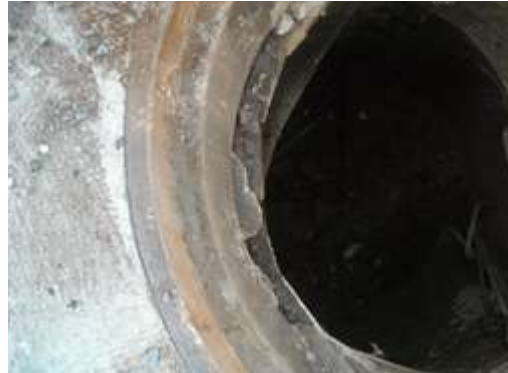
Defect

Frame leaks. Frame offset. Adjustment deterioration, loose brick and infiltration.

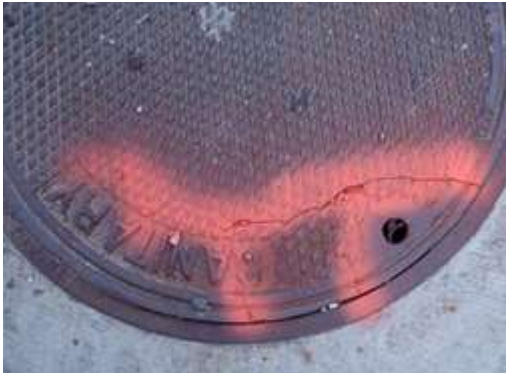
Defect

Cracked cover.

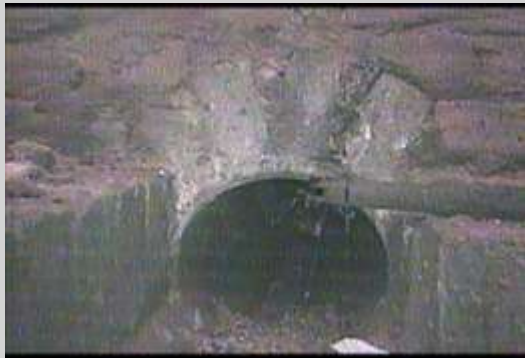
8 in. Circular Gravity Sewer Pipe Out @ 12 O'Clock

Channel deterioration.

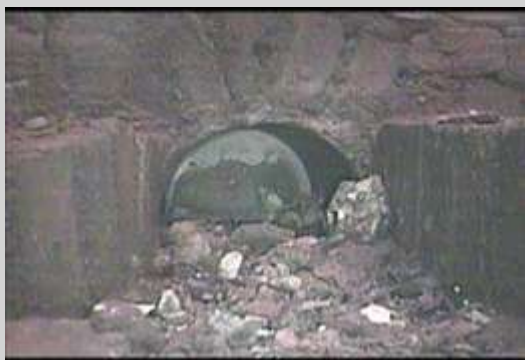
Pipe In @ 3 O'Clock

Capped. Barrel deterioration and infiltration.
